DEPARTMENT OF TRANSPORTATION**DIVISION OF ENGINEERING SERVICES**

Quality Assurance and Source Inspection

Contract #: 04-0120F4Cty: SF/ALA Rte: 80 PM: 13.2/13.9File #: 69.28**WELDING INSPECTION REPORT****Resident Engineer:**Pursell, Gary**Address:** 333 Burma Road**City:** Oakland, CA 94607**Report No:** WIR-000620**Date Inspected:** 16-Sep-2007**Project Name:** SAS Superstructure**OSM Arrival Time:** 630**Prime Contractor:** American Bridge/Fluor Enterprises, a JV**OSM Departure Time:** 1600**Contractor:** Zhenhua Port Machinery Company, Ltd (ZPMC), Changxing Island **Location:** Shanghai, China**CWI Name:** Lu Jian Ping**CWI Present:** Yes No**Inspected CWI report:** Yes No N/A**Rod Oven in Use:** Yes No N/A**Electrode to specification:** Yes No N/A**Weld Procedures Followed:** Yes No N/A**Qualified Welders:** Yes No N/A**Verified Joint Fit-up:** Yes No N/A**Approved Drawings:** Yes No N/A**Approved WPS:** Yes No N/A**Delayed / Cancelled:** Yes No N/A**Bridge No:** 34-0006**Component:** Tower Mock-up 77M and 114 M**Summary of Items Observed:**

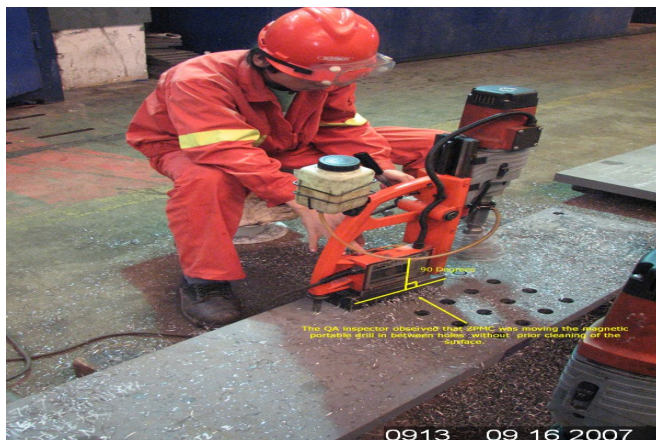
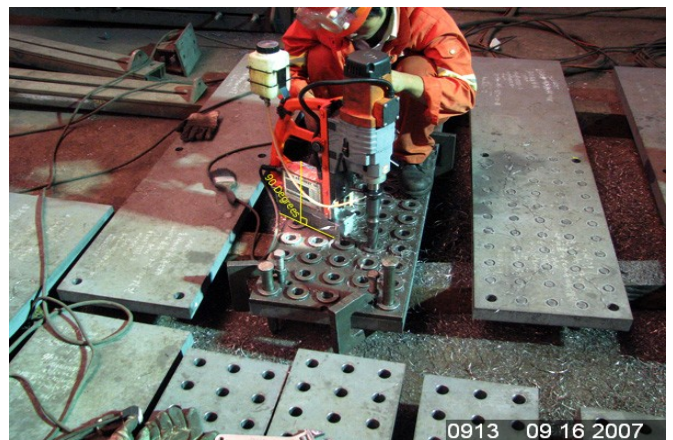
Item	Description	WBS	Dwg No.	Status
2	Drilling operations Tower Mock-up 114 Longitudinal Stiffeners			
	The QA inspector observed ZPMC performing drilling operations to the longitudinal stiffeners. The QA inspector observed that the material removed by drilling operations was not being cleaned from the steel before ZPMC operators moved the magnetic portable driller to another location.			
	The QA inspector had a conversation with the ZPMC QA inspector Li Xiu Yang. The QA inspector asked Mr. Li how ZPMC was preventing that the residues from the drilling operations were not going in between the piece to be drilled and the magnetic portable driller. Mr. Li questioned ZPMC production personnel prior to responding back to the QA inspector. Mr. Li relayed to the QA inspector that when the material was trapped in between the piece and the driller, the magnetic support from the driller was not going to be stable and then the operator would clean the surface. The QA inspector did not observe any deviation which indicated a lack of perpendicularity of the drill bit at this time. The QA inspector recommended to Mr. Li to maintain a true perpendicularity in between the pieces and the portable magnetic driller by maintaining clean surfaces and perpendicularity as per contract documents.

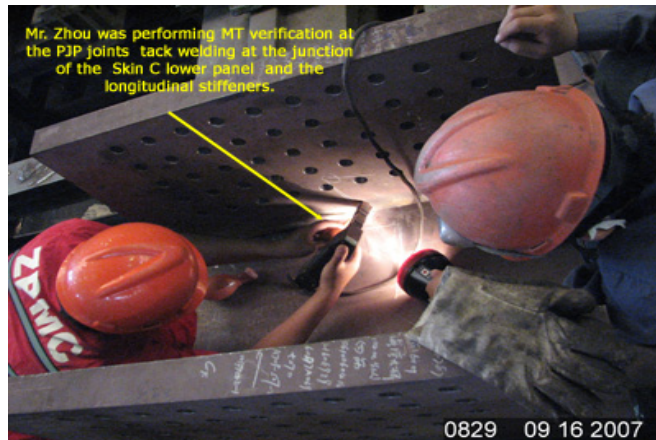
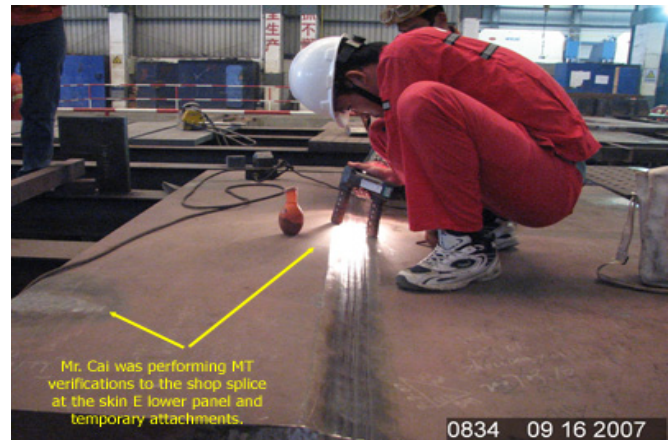
The QA inspector witnessed ZPMC performing MT on cover passes of weld joint 5 and 6 at the skin E lower panel and areas where temporary attachments were removed. The QA inspector observed MT ASNT Level II technician Cai Xin Xin performing MT verifications. The QA inspector observed that Mr. Cai's MT verifications appeared to be in compliance with the Contract documents.

The QA inspector performed 10 % MT verification on the cover passes from the skin lower panel E weld joint # 5 and 6. The QA inspector observed that the weld examined appeared to be in accordance with the contract documents. See TL 6028 generated on this date.

The QA inspector witnessed ZPMC performing MT on the tack welds at the junction of the skin C lower panel to the longitudinal stiffeners joints # 6, 7, 9, 10, 12 and 13. The QA inspector observed MT ASNT Level II technician Zhou Dongyun performing MT verifications. The QA inspector observed that Mr. Zhou's MT verifications appeared to be in compliance with the Contract documents.
